## TR250 & TR6 Brakes Overhauling Handbrake

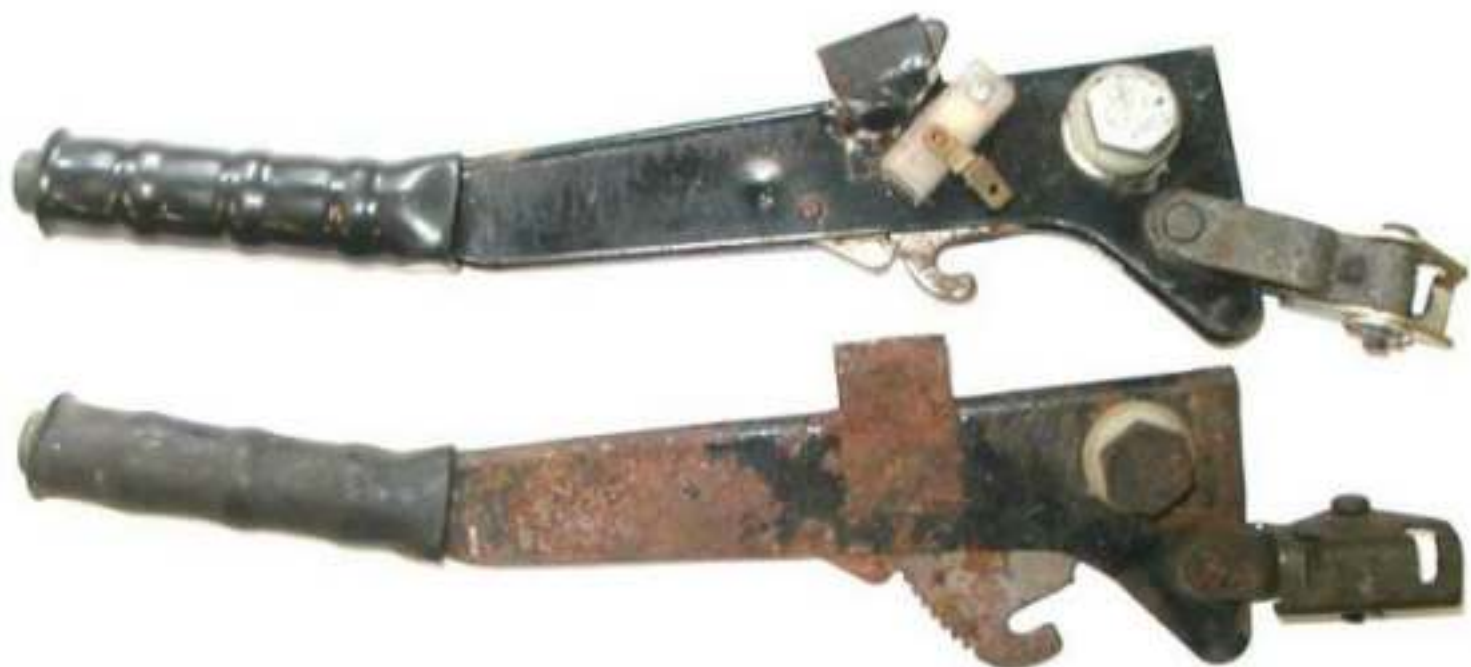
The photo below show a close-up of a lever assembly from a '76 I junked years ago (top) and the lever assembly from the '70 I'm overhauling (bottom) The added switch is clearly visible on the upper lever. The TRF catalog notes that a different grip was specified for the '76 but apparently never used. The Moss catalog shows a grip with a nearly rectangular outer cross section that must be the later version. I've never seen a one of the rectangular grips on any TR6. I assume they used stock of the earlier part and had enough to last through the end of TR6 production.

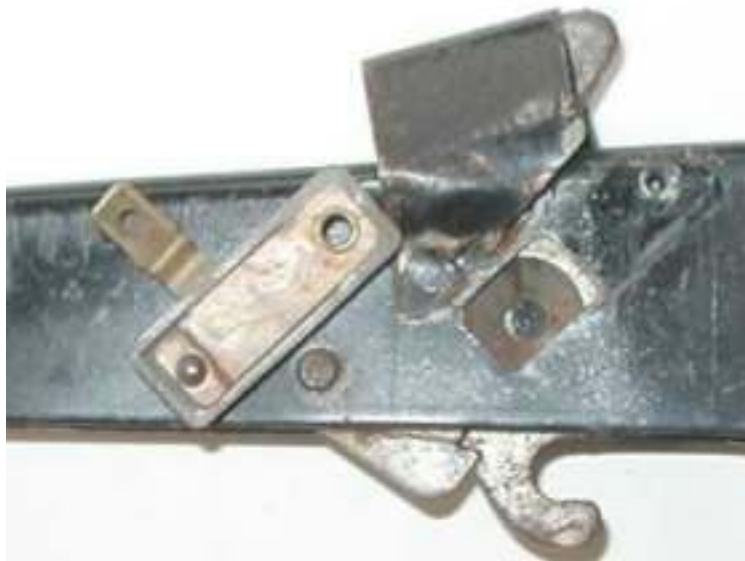
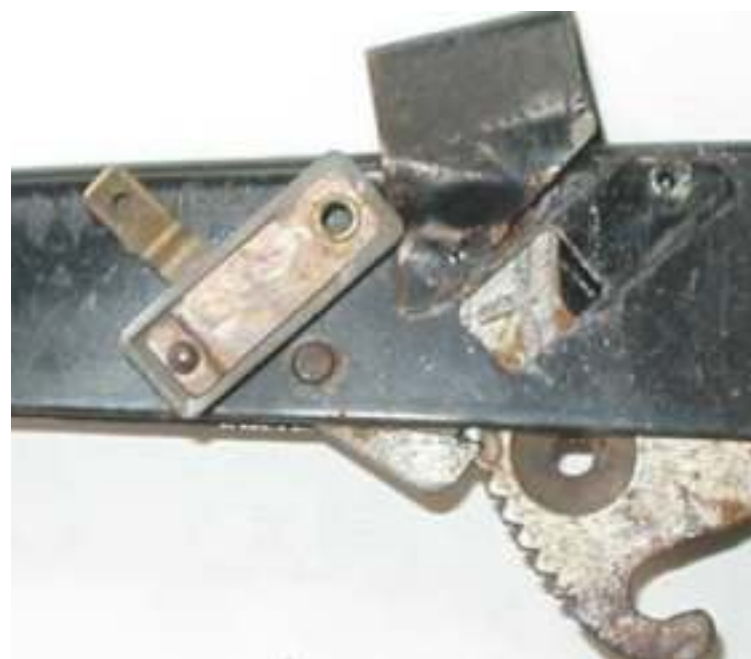
The next photos shown the switch area in more detail. The screw that holds the switch to the handle has been removed and the switch has been turned over. The switch has a metal dimple that sticks down. The left photo shows the ratchet segment in the handbrake released position with a hole under where the the dimple on the switch rests so that no electrical connect is made. The right photo shows the ratchet segment in the handbrake operated position where the switch dimple will be grounded to the ratchet segment (the hole is visible below the handle). Note that a corner of the strap shield over the top of the ratchet segment had to be cut to make room for the switch. Also note that the ratchet segment had to be modified with the hole.

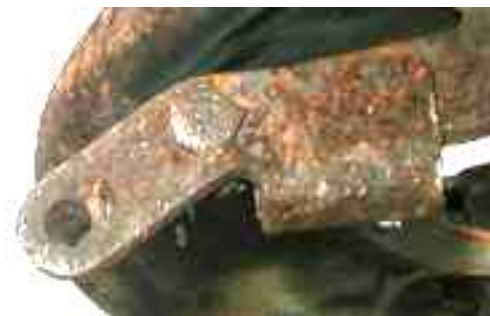
The other change made at CF50,000 was the addition of the extension to the lever in the rear brakes. A very rusty extension on a right side brake is shown on the right. I've found no explanation as to why the extension was added. It will obviously allow a greater force to be exerted by the handbrake. The rear wheel cylinder was changed from 0.70 inches to 0.75 inches for the '76 model year which is about the same time. The larger hydraulic cylinder increased the rear brake force relative to the front brake force.

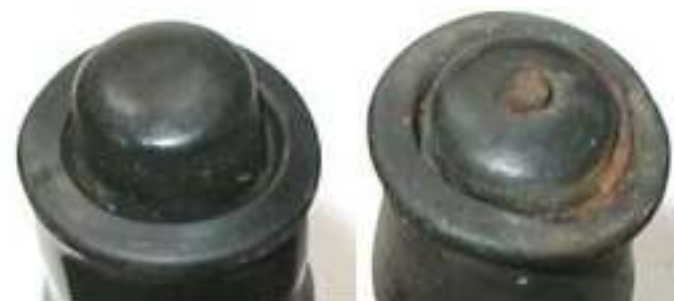
Some of these parts are obviously in worse shape than those of the '76 handle. For example, the '70 paw release knob has a hole as shown on the right. Won't speculate as to why handbrake was applied with such urgency to make the hole. I decided to use any part from the later lever assembly that was the same as for the early lever assembly and in better shape. (I also have a '76 so wanted to keep the unique '76 parts.)

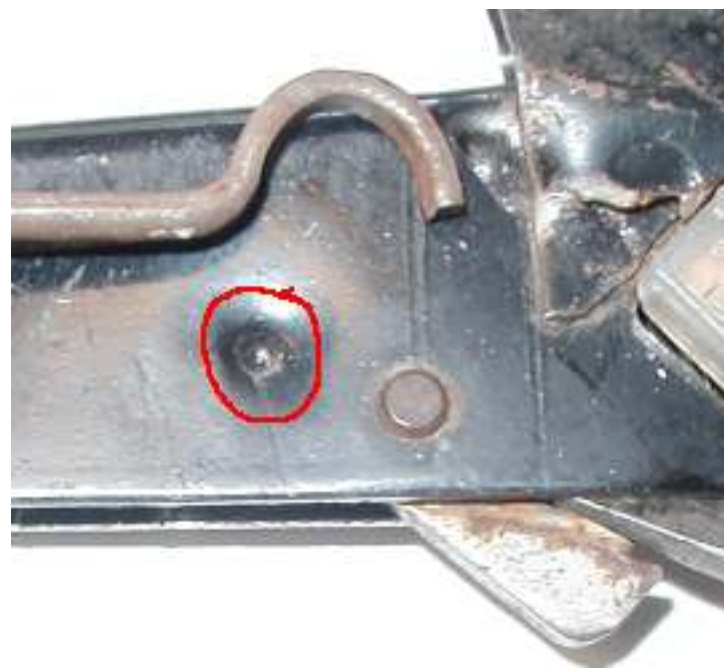
When I tried to remove the Paw release rod from the '76 lever assembly I found it wouldn't come out. It comes right out of the early levers, which is the main reason that I always found it difficult to reinstall the lever. The paw would slide around and let the paw release rod fly out of the handle just when I had it about positioned. The late lever has dimples on each side of the lever to keep the paw from rotating far enough for the paw release rod to escape. The photo on the right shows the dimple in the red circle. The paw release rod from the other lever is setting on top this lever to illustrate the rough position of the rod inside the lever. I decided to modify my early rod so the paw release rod would be retained. Rather than dimples I drilled the lever in the same spot as the dimples on the later lever and threaded one side for an 8-32 stainless steel machine screw to restrict the paw motion. The dimples were drilled out of the later lever so I could get the paw release rod out and move it to the early lever.

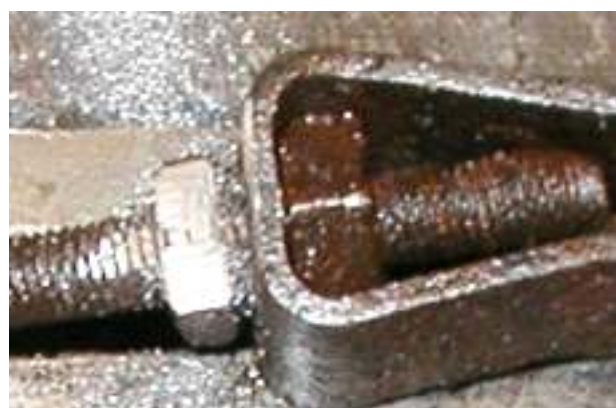
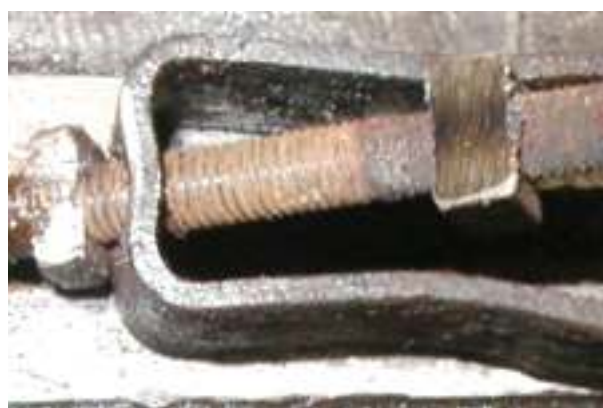
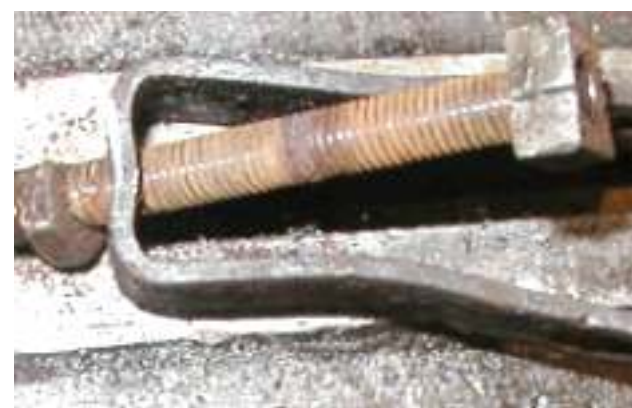
**The Cables:** I had secured new cables for this project. When I went to find the fork-ends that go between the cable and the rear wheel cylinder lever I found a pretty decent set of cables with the nuts securing the fork-ends rusted solid to the cable. I could have merely sawed off the end of the cable to free the fork end but then I'd have ruined a good set of original cables that I can probably sell on ebay for twice the cost of new cables (they are original). I ended up grinding & filing one side of the jamb nut and then using a sharp chisel to split the nut open. I could then screw the nut all the way on the cable, slide the forked end all the way on the cable and do the same grinding-filing-chiseling to loosen the square adjustment nut. The photos below show the sequence.

I've always had trouble with these nuts rusting. The use of the square nut has been a puzzle. If it was bigger, it could be screwed in or out by rotating the fork-end. My guess is that the square nut was used as a safety measure -- the fork end was kept to keep it from rotating and working off. Unfortunately, no one verified the the inside of the fork end was small enough to keep it from rotating. This was probably not a serious problem since most probably rusted solid before reaching the dealers lot. I decided to do a little redesign here. I replaced the jamb nut with a stainless steel nut. I made my own square nuts from 1/4" X

1/2" stainless steel key stock (McMaster-Carr). The nuts are actually rectangular, 1/2" by 5/8". The stainless steel parts should reduce the corrosion problem and the larger nut enables it to be adjusted by rotating the fork-end. The fork-end and clevis pin were powder coated in aluminum. The pin was secured with stainless steel cotter pin as shown in the next photo.
