CTM ENGINEERING TR2-6 CHASSIS WORK

If you have a TR2, TR3 or 3A, TR4 or 4A, TR5, TR250 or TR6 with a suspect chassis, don't despair for CTM Engineering Ltd of Curbridge in Hampshire can repair yours or supply a new, high quality replacement. Kim Henson finds out what they can do to help...

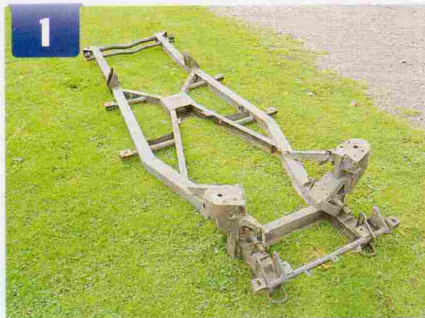
This is a TR3A chassis from Spain, in need of repair due to accident damage but essentially solid, with thick, sound steel evident. In many cases rust will be more of an issue; close inspection after grit-blasting is always required.

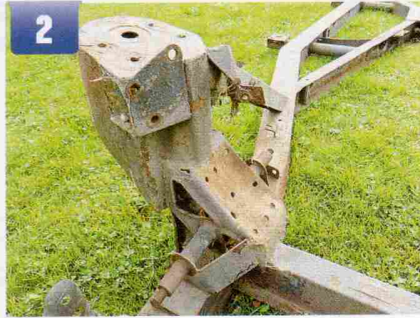
This has engine mounting/fulcrum pin damage, rotating the suspension turret and lifting the chassis at the front. The turrets and brackets require removal and repair or renewal, the side rails must be trued up and a rail corner fitted.

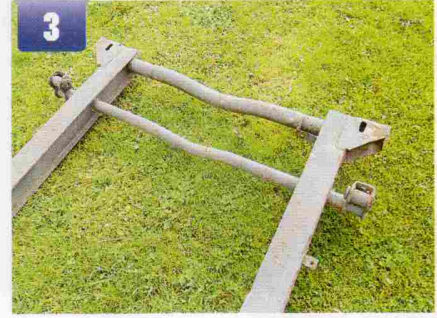
Corrosion within the rear cross-tubes of early type chassis can be a problem. CTM fit inserts within the tubes to strengthen this area of the structure. Gearbox mountings can split too; CTM welds gussets in place for a strong repair.

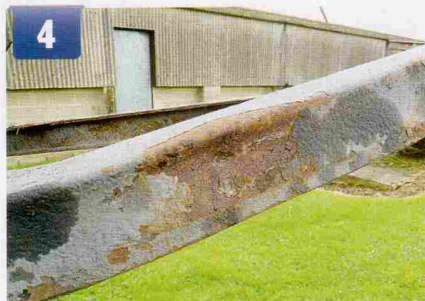
This TR3A chassis is pictured on its side, highlighting the damage typical of that inflicted by careless use of a trolley jack. Folding of the metal in a concertina-type manner can also occur due to accident damage (compression).

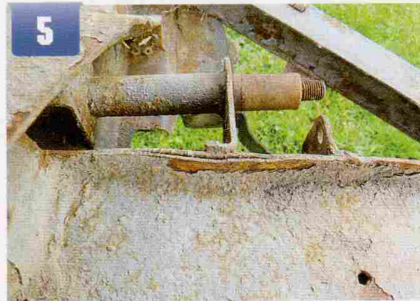
Impact damage and corrosion can result in separation of two layers of steel, as in this case, adjacent to the front suspension mounting area on a TR3A chassis. CTM can usually repair damage of this nature, depending on its extent.

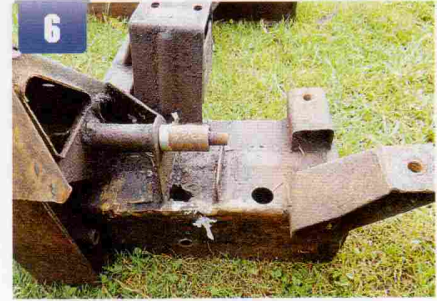
To cater for TR4 models, the front rails of TR2/TR3/3A chassis were widened by approximately two inches on each side with the addition of a box section. (Note that at the rear the chassis are similar, but the TR4 axle is wider).

As already noted, the front of a TR4 chassis is widened by the addition of box sections. If the steel is thin, the front of the chassis has to come apart for renewal of this complete assembly as the inner box sections are not easily repaired.

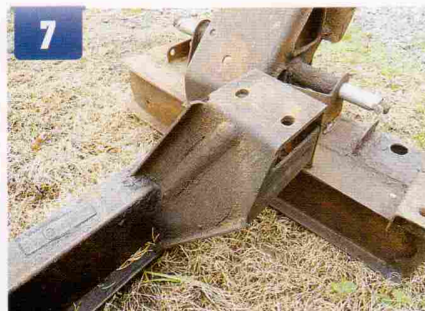
CTM can supply new steering rack mounts; for all but the earliest cars they often re-use the original factory-pressed mounts (those in this shot are the later TR4 variety). If you own an early TR4, CTM can supply the later mounts.

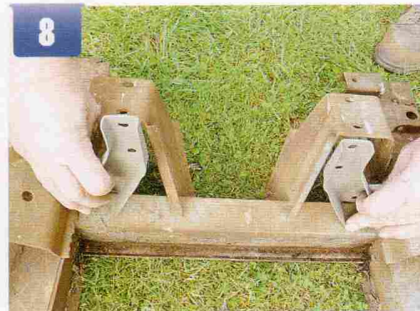
You can upgrade from the vertical, early type rack mountings to the far stronger later type, which are more suitable for radial tyres, wide wheels and more positive steering, or the early mounts can be strengthened by CTM.

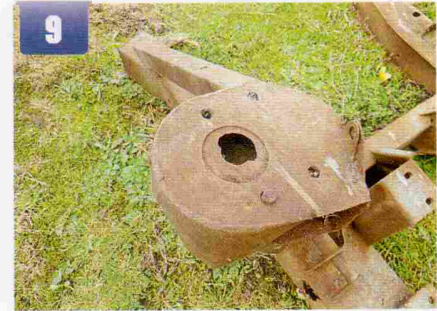
Rust can take its toll in the front turrets, around the upper mountings for the shock absorbers; in some cases the turret tops can be holed and considerably weakened. This is a TR4 chassis, in a bad way in this respect.

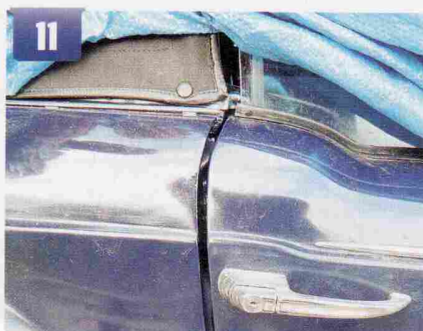
The rear of the chassis tends to drop in time, and on rusty cars the problem can be very bad. On TR4As, TR5s, TR250s and TR6s, a sign of major corrosion damage is a door-to-rear bodywork gap wider at the top than the bottom.

It is not always fully appreciated just how vital the condition of the chassis is to the looks and – especially – the dynamic performance of a TR. Even if the metal is sound, the rear end of the chassis frame tends to drop in time, especially if it is rusty. A give-away on TR4A, TR5, TR250 and TR6 versions is the profile of the gap between the trailing edge of each door and the rear bodywork against which it closes; the gap on each side of the car should be reasonably small and uniform. If it is wider at the top, this indicates that the rear section of the chassis has dropped. While installing more packing between the rear of the chassis and the

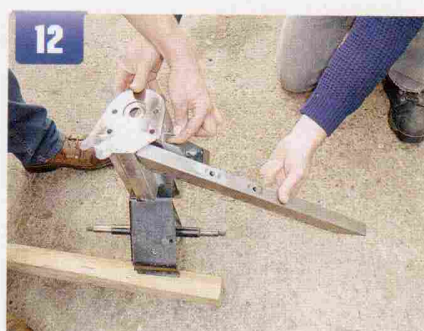
These components are made by CTM for TR2, 3, 3A and 4 models, to address problems often found at the front of well-used original chassis. Shown here are the turret assembly, fulcrum pin unit, turret support bar and bump stop mount.

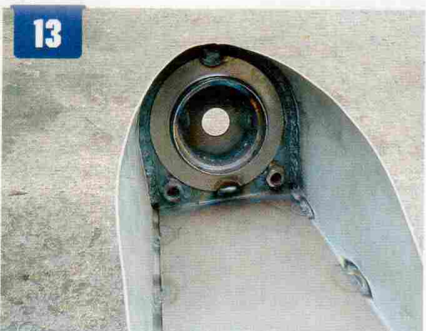
The top of each front coil spring mounting turret is a favourite place for rust to accumulate. CTM manufactures new assemblies; these are complex structures, as can be seen when looking into this TR2/3/3A/4 unit from below.

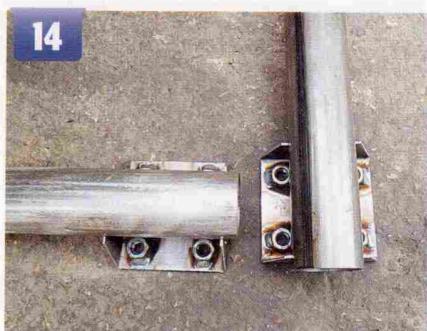
New outriggers and their mounting saddles are also made by CTM, and securing nuts are welded to the undersides of the saddles, as shown here. Note that the outrigger tubes on the TR4 are longer than those of earlier cars.

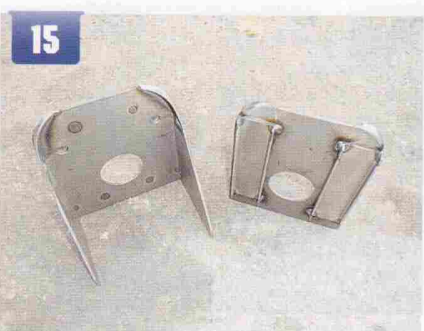
For TR2, TR3, TR3A and TR4 chassis, new mountings to accommodate lever arm type shock absorbers look like this; the mountings are similar for all chassis. An uprated version is available to suit larger lever arm units.

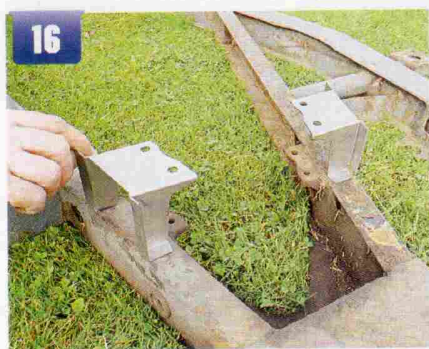
16 Gearbox/overdrive mounts are produced for inclusion in the chassis (in this shot the new mounts are shown directly above the positions in which they would be fitted to the chassis). Please also see photos/captions 25 and 26.

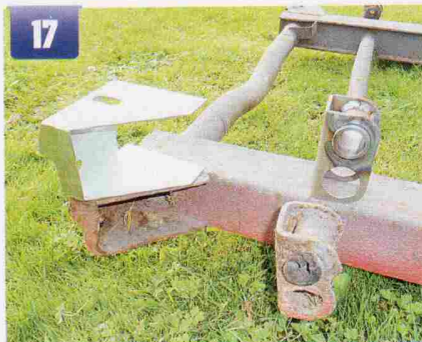
17 On the left is a new chassis bracket, designed to link the rear end of the chassis to the body and over-rider. On the right is a newly-made mounting assembly for a rear leaf spring. (For TR2-4 models, all new parts are used).

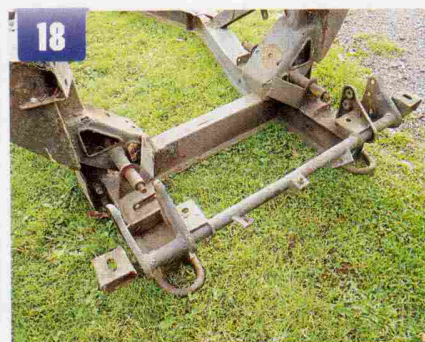
18 If the steering box and idler mounting assemblies are sound, CTM prefers to re-use them as they are original pressings, but if they are ailing, reproduction items are available. A new cross-tube and body mounts are fitted.

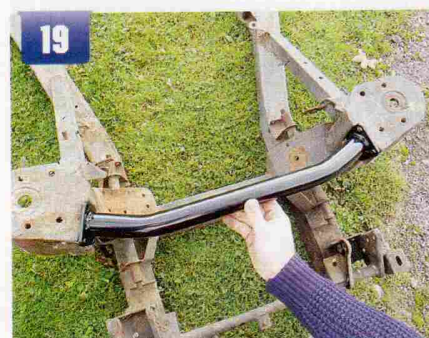
19 CTM manufactures new cross-tube braces to bolt between the suspension turrets and tie together the front of the chassis (preventing random changes of camber). A TR3 chassis is shown here, but this also applies to the TR4.

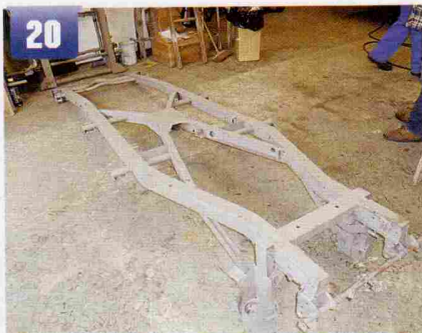
20 On arrival at CTM/removal from the vehicle, each chassis frame assembly is cleaned, then shot-blasted to reveal all blemishes, corrosion, previous repairs and so on. This is a TR3 chassis after shot-blasting...

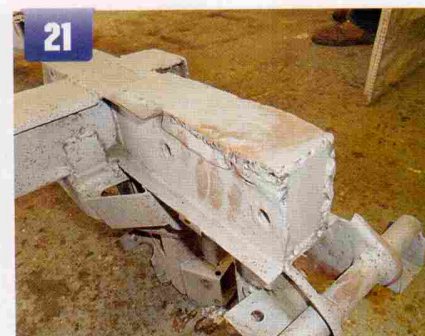
21 ...and this is the damaged front end of one of the side rails. Further problems (highlighted by shot-blasting) on the same chassis included a cracked fulcrum pin and leaf spring mounting, as well as several dented areas.

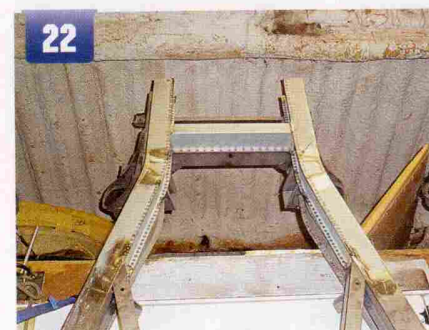
22 This is another example of a TR3 chassis, in this case one that has already been through the CTM repair process. Serious accident damage required the grafting on of new front rail assemblies, which were welded in place flush.

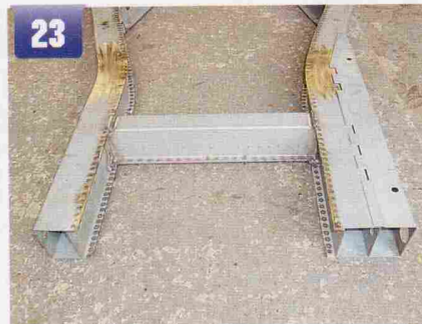
23 The chassis of a TR3 differs from that of a TR4, particularly because the front rails are wider. On the right of this shot is the new additional outer box section to provide the additional extra width required (one is needed each side).

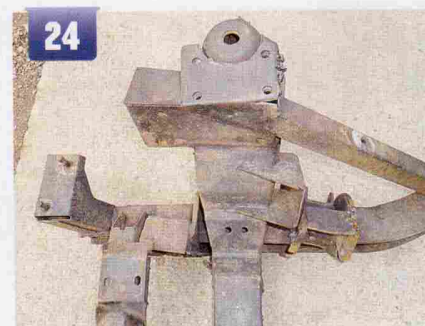
24 The later TR4A, TR250, TR5 and TR6 chassis are all virtually the same and differ from those of earlier models, although many of the techniques to repair them are similar. This TR6 chassis has been badly damaged in an accident to the front.

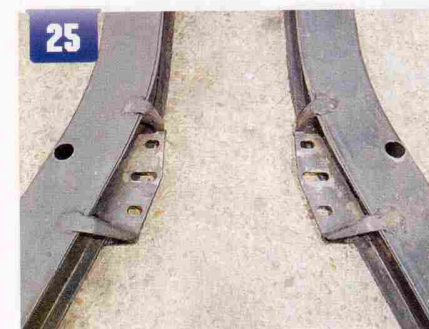
25 This late TR6 chassis (1973-76) has mounting points for a Laycock J-Type overdrive. Where fitted with overdrive, older cars (TR4A/TR5/TR250 and early 'CP' TR6 to 1972) had A-Type units, which are now more difficult to source.

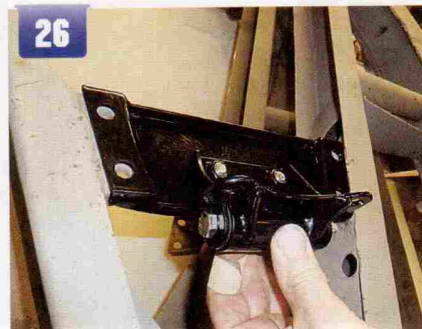
26 CTM sells a modified bracket to accommodate a J-Type gearbox/overdrive (readily available from Triumph saloons). The firm also makes this conversion mounting to fit a later J-Type gearbox/overdrive into a TR2/TR3/TR4 chassis.

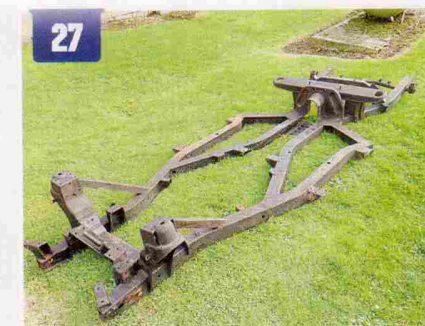
27 This TR4A chassis (cleaned, but yet to be blasted) has the same side rail construction as the TR5, TR250 and TR6 models, but the front suspension turrets and the hump at the rear differentiate the assembly from that of later cars.

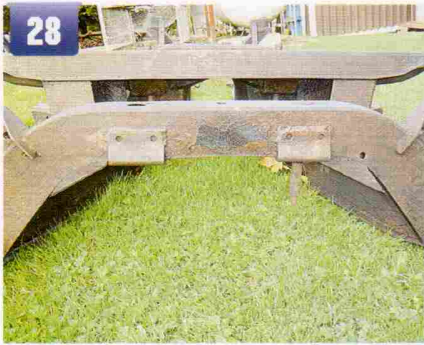
This fatigued rear bridge assembly is on a TR4A chassis, and shows typical damage sustained after years of service. The holes in the bridge tend to elongate in time, and the mounting pins can break away (one has gone from this unit).

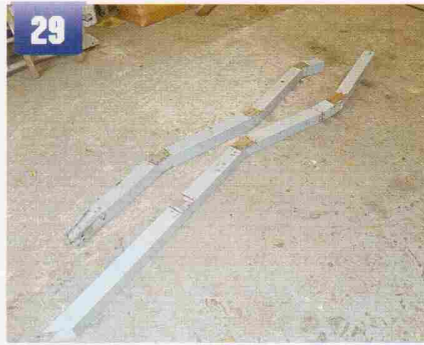
This is a new set of side rails for a TR4A-TR6, with the metal already CNC punched and folded. These typical sub-components are ready for installation in CTM's jig to be clamped and welded together into a full chassis frame set.

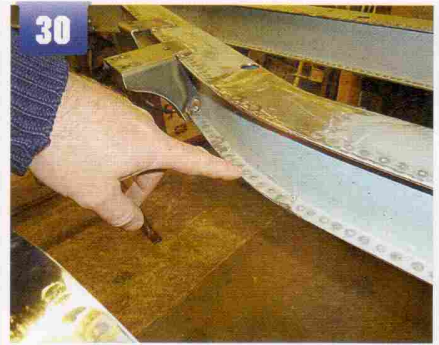
When all chassis components are laid in the jig in their correct relative positions, they are spot-welded together using welds at very close intervals (c800 welds per chassis!). The original beams were pressed, but these are fabricated.

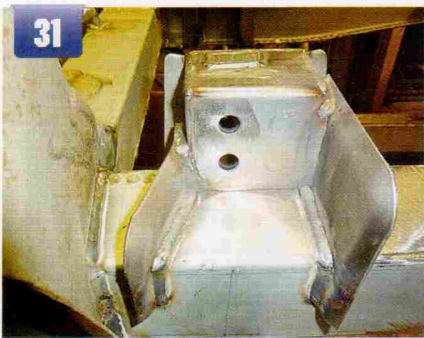
All suspension brackets/mounts are reinforced; compared with the original TR4A-TR6 chassis, CTM adds extra metal to all potentially weak areas. All new and repaired chassis are stamped with their name and bear a unique serial number.

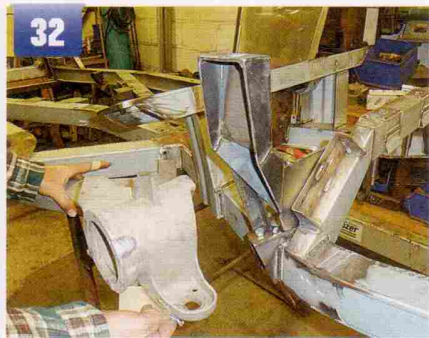
This is a superior triangulated bracket/mounting set-up to enable telescopic shock absorbers to be used at the rear. The main bolt-in bracket has been modified/lowered so that wider than standard wheels and tyres can be fitted.

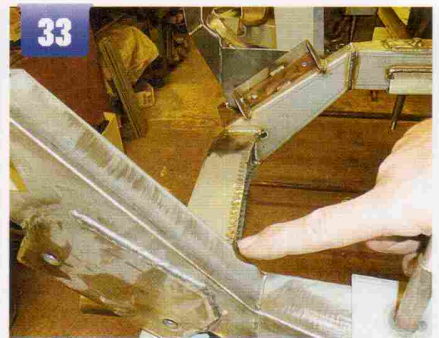
Reinforcements are welded into the underside of the bridge assemblies (for the rear of the chassis), significantly improving their strength and rigidity. This is a new bridge (this channel is open on an original factory Triumph chassis).

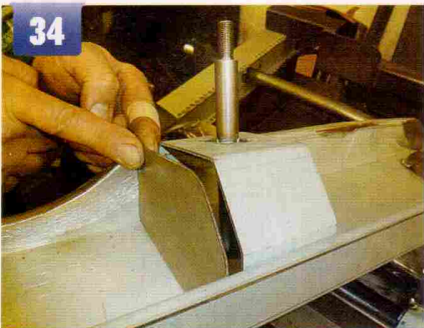
A kit of reinforcement plates is available from CTM to upgrade a standard chassis' bridges. The additional steel sections include strengthener plates designed to be welded in position in the vicinity of the differential mountings.

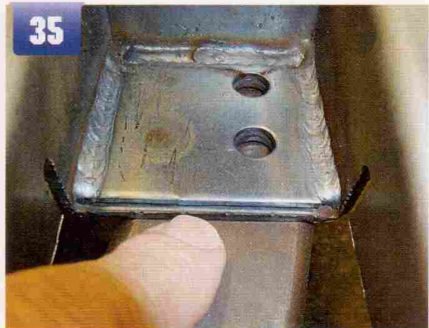
CTM build into their chassis additional reinforcement plates to strengthen the mounting points for the lower suspension arms. This considerably enhances the structural integrity of these areas on the TR4A-TR6.

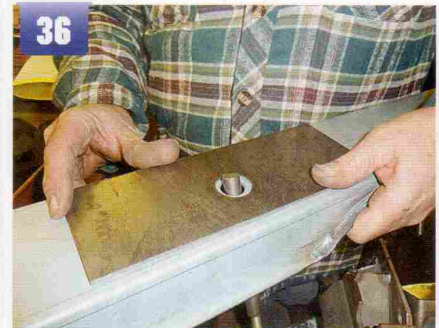
Strengthener plates are also made and welded into place on the bridge at the rear of the chassis. Larger plates are fitted to original chassis, to help spread the loadings over as wide an area as possible.

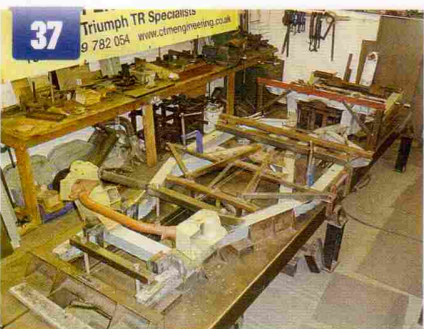
The key to a perfectly set-up TR chassis – this is the all-important jig, developed and built by CTM to ensure dimensional accuracy and a perfect fit for all the various chassis components, which are clamped and then welded in position.

Colin carried out extensive research, including studying Triumph drawings and putting together his own data based on working with original chassis in good condition. As a result, during the late 1980s he was able to develop and fabricate his own purpose-made jig, on which the complete chassis structure can be mounted to ensure dimensional accuracy and a perfect bodywork fit – every time. Cleverly, the jig is built to accommodate all the variations from TR2 to TR6 as, through the years, the original chassis was developed and altered by Triumph.

With the chassis mounted in CTM's jig, localised damage can be cut away and new sections flush-welded in position, with hidden internal reinforcements incorporated in all joints. In some cases complex rebuilding can be carried out – for example if the existing centre section of an early type original chassis is sound but the side rails are in need of replacement, new rails can be welded to the original centre assembly. In each case, whether the existing chassis is repaired or a new one is built, shot-blasting is carried out following welding. This ensures that all rust is banished, and also helps to relieve the metal of stress imparted by the welding process.

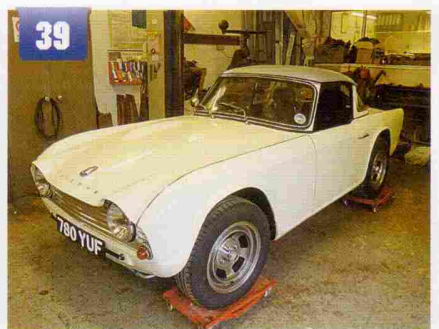
In addition to its chassis repairing/manufacturing operations, CTM Engineering Ltd. carries out all types of work on TRs, from maintenance to full restoration. This beautifully-finished TR4 has just come to the end of a full restoration.
