## TR250 & TR6 Brakes Overhauling Handbrake

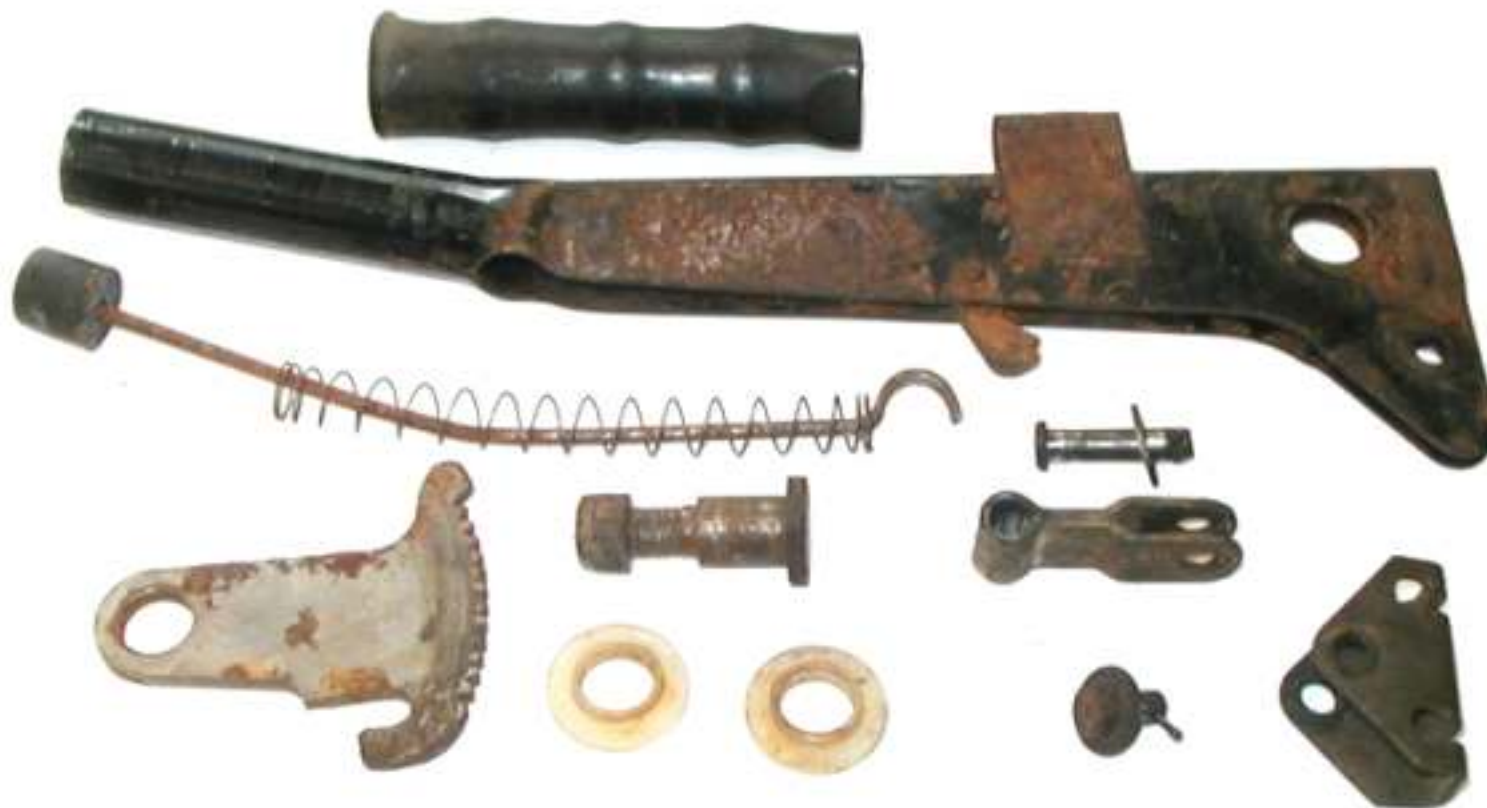
**Overhauling the lever Assembly:** The next photo shows the disassembled '70 lever assembly.

Some of these parts are obviously in worse shape than those of the '76 handle. For example, the '70 paw release knob has a hole as shown on the right. Won't speculate as to why handbrake was applied with such urgency to make the hole. I decided to use any part from the later lever assembly that was the same as for the early lever assembly and in better shape. (I also have a '76 so wanted to keep the unique '76 parts.)
