CAR

MECHANICS

TR4 tips

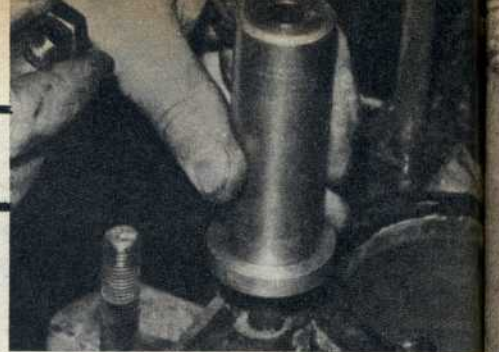
CYLINDER LINERS of the wet type are retained by the cylinder head. Consequently the engine must not be rotated when the head is removed until the liners are clamped into the cylinder block. Two distance pieces will hold all four sleeves when bolted to two head studs

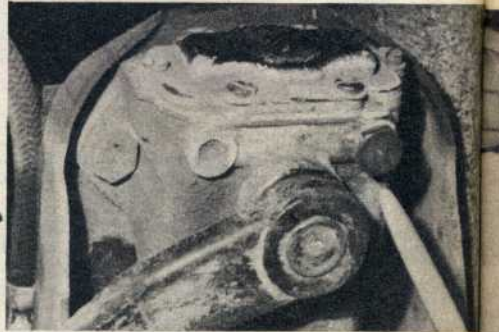
TELESCOPIC DAMPERS at the front require no attention. The rear piston-type dampers will require to be checked and topped-up at fairly regular intervals via the filler plug indicated in the illustration. It is essential to use only Armstrong shock absorber fluid for this

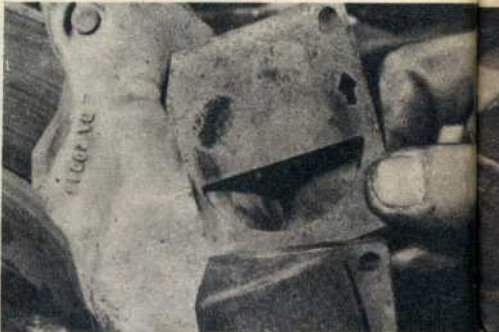
THE SHIM shown in this illustration is fitted between the brake pad and the piston in order to reduce any tendency for the brake to squeal. It is, however, very important that this shim should be fitted with the arrow marking facing the direction of normal wheel rotation

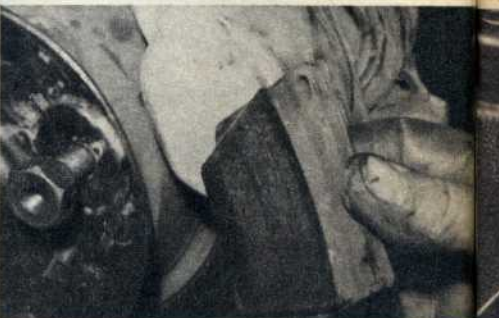
DISC BRAKES are self-adjusting, so inspect the pads at frequent intervals. Once the thickness of the lining is reduced to $\frac{1}{8}$ in., new pads should be fitted for it is dangerous to permit them to reach a low of $\frac{1}{16}$ in., not to mention the damage to the disc which will result

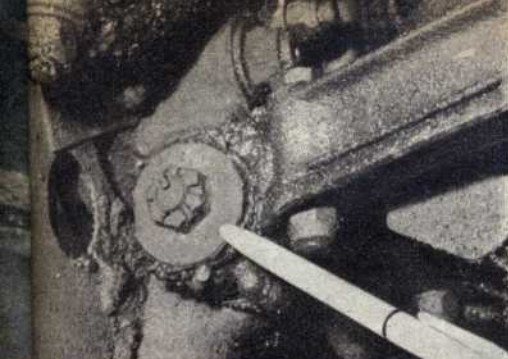
WISHBONE ARMS at the outer ends of the lower front suspension should not have the two castellated nuts over-tightened as this would tend to seize the suspension. An end-float of .004-.012in. is achieved by tightening the nuts and slackening two flats before fitting pins

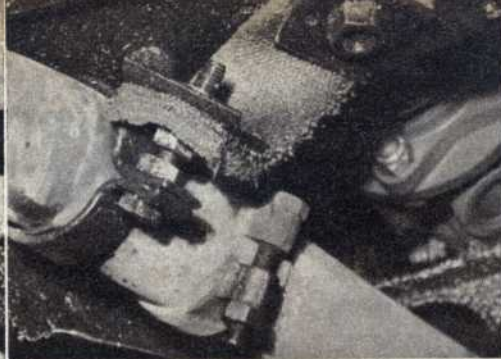
EXHAUST PIPE clearance is very slight round the pipe where it passes through the chassis cruciform and incorrect setting of the pipe can cause a heavy knock when the car is running erratically or over rough roads. Make certain the clamp bracket is kept firmly tightened

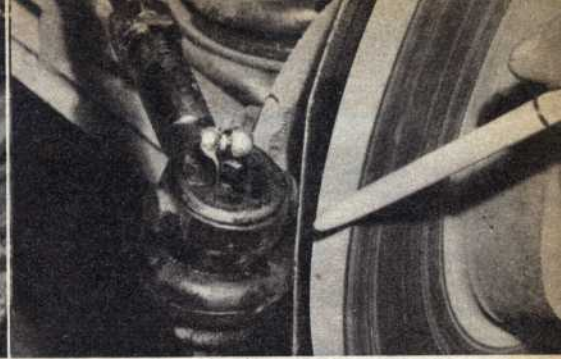
TRACK ROD ball-joints should not in any circumstances be over-greased. Over zealousness will permit grease to escape past the rubber boots and affect braking efficiency as the excess grease will be blown back on to the disc at high speed. Wipe away any excess lubricant

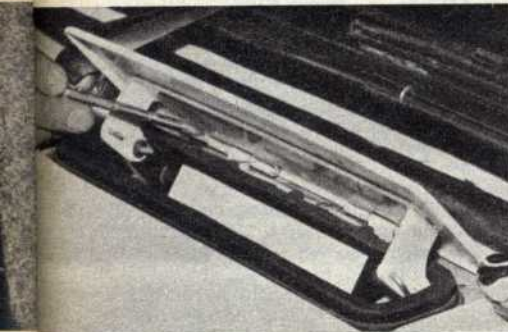
SCUTTLE VENT hinge flaps should be lubricated occasionally. This is one of those small points which are all too frequently overlooked until the day when the flap seizes and brute force snaps the hinges. Inspect closely for any signs of rust as this can be a vulnerable spot

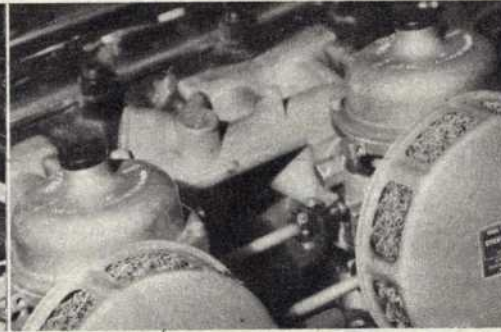
TWIN STROMBERG carburettors (type 175CD) are used in place of the S.U. in later versions. These carburettors can be obtained as a conversion kit at an exchange price of £18 from the Zenith Co. Ltd. They are claimed to provide both better performance and economy

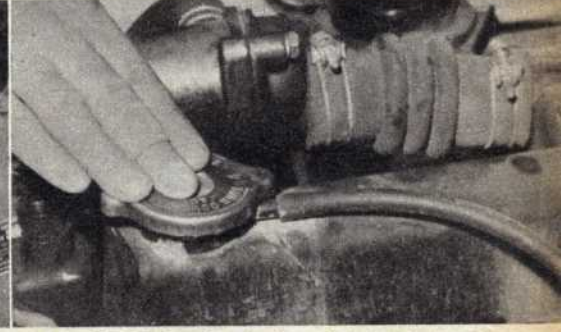
RADIATOR header tank and extension are connected by a soldered joint. When working on the car care should be exercised not to lean heavily on the radiator filler cap as there is a distinct risk of cracking this joint. This has been altered on all the later Triumph models

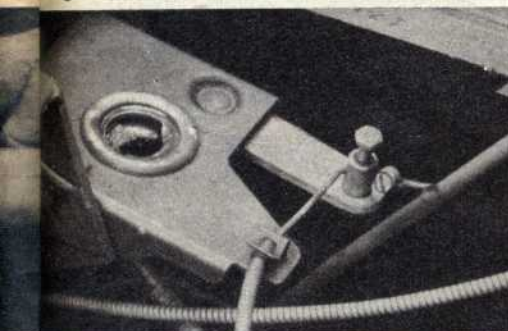
THE BONNET will be difficult to open if the bonnet lock cable pulls through the trunnion. This sometimes tends to occur should the screw happen to work loose. To prevent this unfortunate happening a second screwed nipple is fitted to the cable as additional safety measure

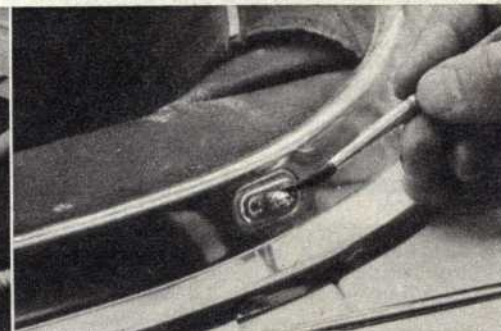
CHROME SCREWS holding the hood clips cannot be fitted without a risk of nicking the chrome surface and, if this occurs, the result after a time could be that the screws will rust. There is a simple means of preventing this. Apply lacquer or wax polish to the screws

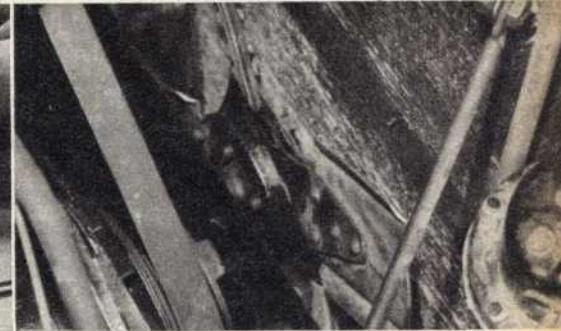
ENGINE OVERHEATING in summer weather has been complained of in certain instances and to overcome this trouble in hot conditions with heavy traffic, the fan blades have been changed to the type shown. The fan can be ordered from a dealer under Part No. 209792

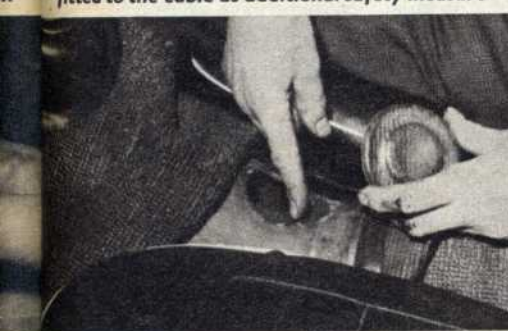
LUBRICATION of the sliding end of the propeller shaft is impossible on the first 8,000 (approx.) vehicles as the grommeted hole in the floor tunnel is out of line. This was overcome by using a 45 deg. grease nipple in place of the original—obtainable from any Triumph dealer

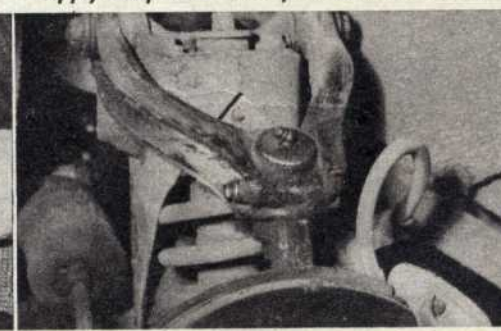
CASTOR ANGLE on the front wheel was slightly altered at chassis No. CT16344 (wire wheels) and CT16390 (disc wheels). This was done by altering the upper wishbone arms, top ball joints and trunnions on the front suspension. Ensure you obtain the correct parts

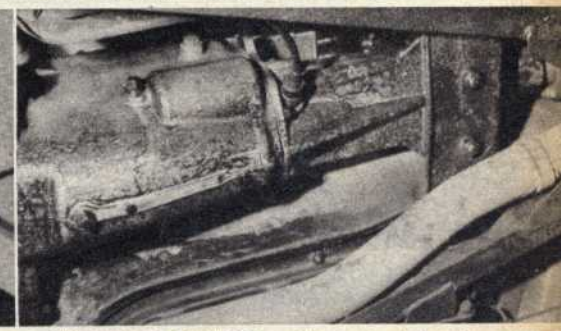
VIBRATION PERIOD on this powerful engine is at 2,700-3,000 r.p.m. The effect of the vibration has been reduced on later models after chassis CT1800 by fitting a damper to the gearbox or overdrive extension housing. A Triumph dealer will be able to supply the parts required
